## CASE STUDY : HEVER STATION EMERGENCY CUTTING WORKS

CK Rail safely completed over 6,500 hours of emergency work to repair and strengthen a railway cutting at Hever station in Kent. Engineers were onsite within two hours of reports a landslip had occurred south of platform 1 at the station on the Uckfield branch of the Oxted line. An initial incident survey and report identified significant ground movement had occurred and there was evidence of slope failure. CK Rail were appointed to complete the essential work to secure the cutting and ensure the railway line could safely remain open.

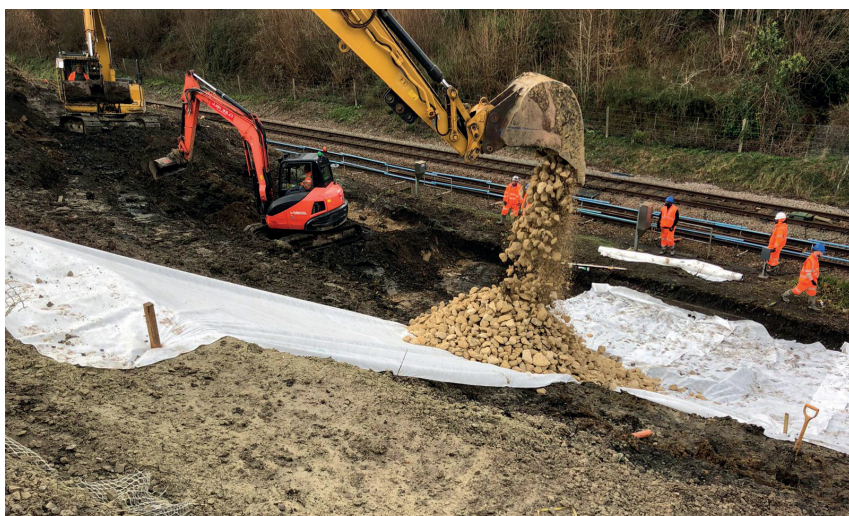
The core works included clearing and removing a total of 141 tonnes of spoil material from the cutting. Engineers then implemented the agreed engineering design solution which included the installation of a 45-metre king post wall to retain the slope, embedded 12metres below ground level to secure the cutting. A piling platform was created using 75 piles driven into the ground, installed at the crest of the slope and a retaining wall was constructed at the toe of the cutting with 88 gabion baskets erected and filled with 1,605 tonnes of gabion

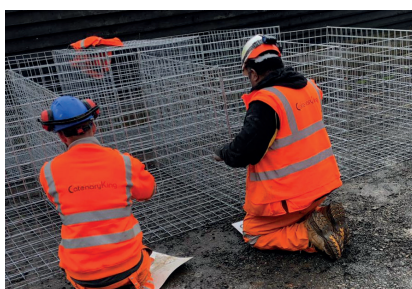
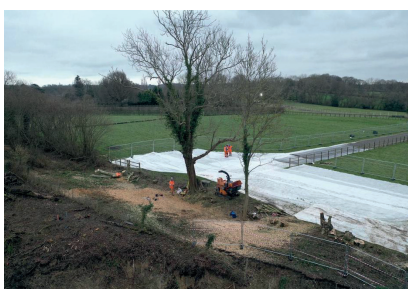
On completion of this vital work, demobilisation of the site commenced, including comprehensive remedial work to reinstate the surrounding area. Engineers installed 50metres of new fencing and planted two oak trees and 18 silver birch trees. CK Rail were delighted to have safely and successfully completed these emergency earthworks, ensuring a safer, more reliable and sustainable rail network.
